# **Raytec Vario2.5 Hybrid IPPoE Firmware Release Notes**

## 1. Release Version 3.7.1 (June 2023)

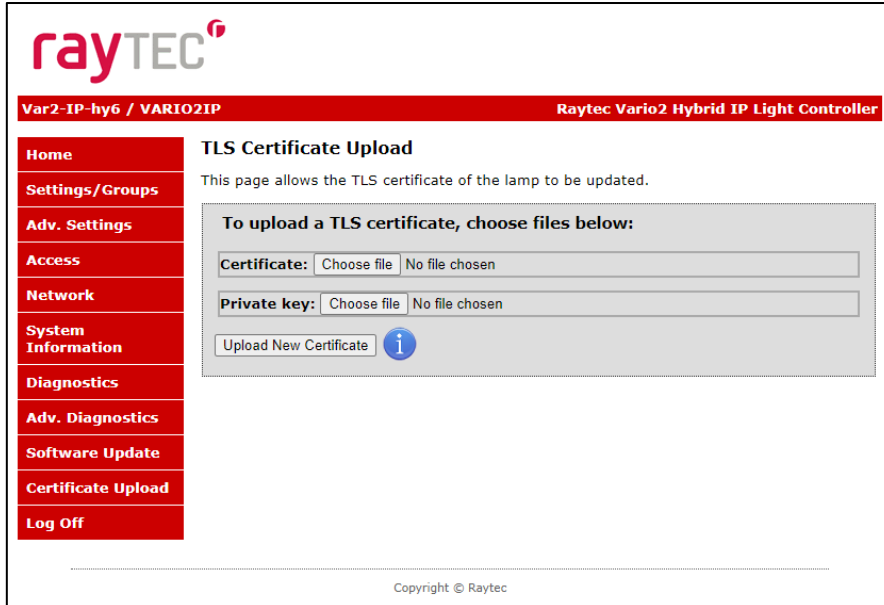
*The web interface now has a page Certificate Upload which looks as follows:*

*The user must upload a certificate file and private key, these files must be in .der format as this makes the files smaller and allows them to be uploaded and stored in a timely manner.*

*It is important that files uploaded use ECDSA 256-bit keys, the reason this has been chosen by Raytec is because we have a memory and power constrained device and by using ECDSA with 256-bit keys (over something like RSA with 2048 bit keys) is to give our users security whilst keeping the product working without any lags or issues, our processor doesn't have the capability to do RSA encryption/decryption in a timely manner.*
